Stacked for Success by Drs. Isaias Íñiguez and Laiza Íñiguez Smith

Layering bulk-fill composite and high-strength fibers to treat a cracked tooth can create an interim treatment that lasts 10 years and counting

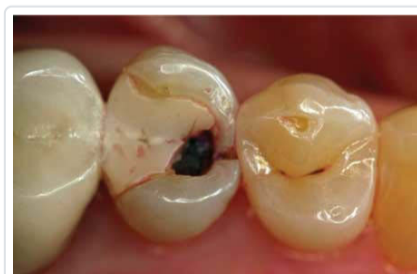
Fig. 5a

A 68-year-old patient presented complaining of cold sensitivity, along with pain upon chewing, and requested an immediate solution. The clinical examination and X-ray demonstrated a failing Class II resin restoration in Tooth #13 (Fig. 5a). A preoperative periapical X-ray was taken (Fig. 5b). A mesial-distal crack was present with no apparent periodontal pocket. All other maxillary teeth were checked and found asymptomatic. The diagnosis was cracked tooth syndrome.

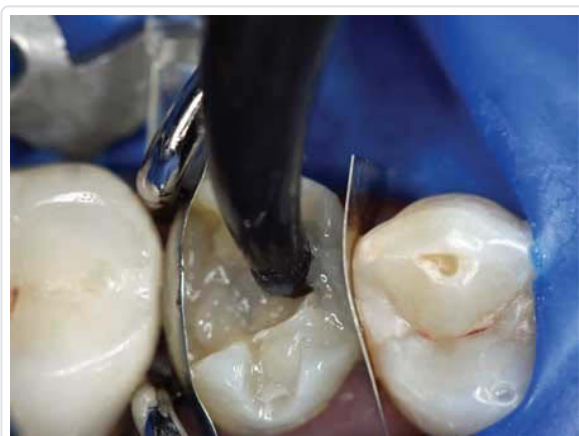
Fig. 10

The bulk-fill technique included two layers, beginning by applying one small increment of bulk composite (SonicFill, Kerr, Fig. 10), then two 2mm pieces of high-strength polyethylene fibers (Ribbond) blotted with an unfilled bonding adhesive. Excess was removed with lint-free gauze. The fibers were firmly inserted into the uncured composite in the mesial-distal direction (Fig. 11). The other piece of high-strength polyethylene fibers was tightly introduced onto the uncured composite in the buccal-lingual direction (Fig. 12). The fibers were adapted and pressed (Fig. 13) as close to the pulpal floor as possible, then light-cured. This increment will be the base or liner (Fig. 14). Lastly, the thickest increment was applied with the same bulk composite.

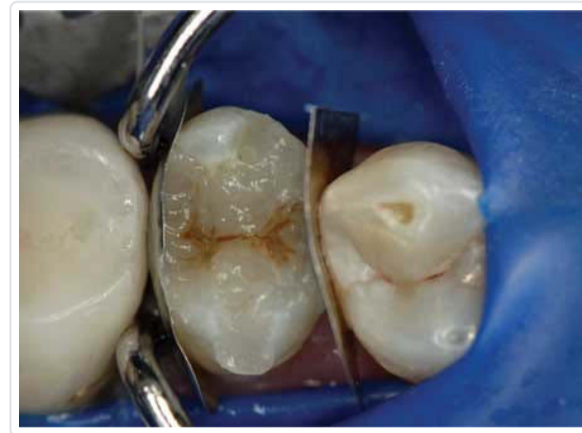
Fig. 15

Tints (Color Plus, Kerr) were placed to create tertiary anatomy (Fig. 15). Glycerin was placed on all surfaces to avoid the oxygen inhibition layer, ensuring total polymerization of the composite, then light-cured¹⁴ (Fig. 16). The rubber dam was removed and occlusion was inspected in all eccentric movements to avoid any premature contact.

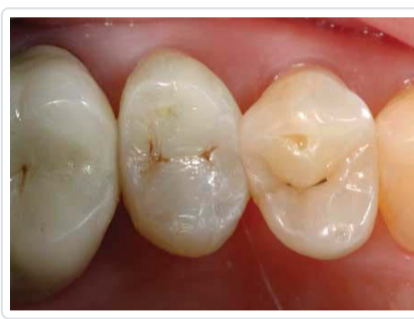
Fig. 17a

Then, the contoured restoration was polished with intraoral polishing paste (DiaShine, VH Technologies), using a latch brush and keeping light in constant contact with the restoration. This provides higher surface luster (Fig. 17a). As a preventive measure for occasional bruxism, the patient was provided with a night guard.¹⁵ A postoperative periapical X-ray was taken (Fig. 17b).

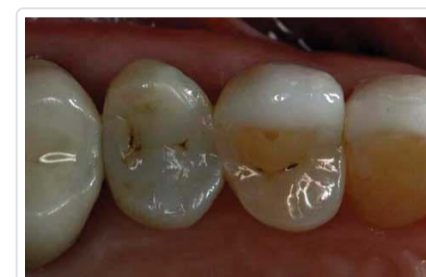
Fig. 18

We explained to the patient that this is a temporary aesthetic fix, done to facilitate further treatment planning. It does not represent a definitive treatment solution. So far, the restoration has survived an eight-year follow-up (Fig. 18). We did not find the presence of crack extension into the pulpal floor. To this day, the patient has decided to leave the restoration untouched.

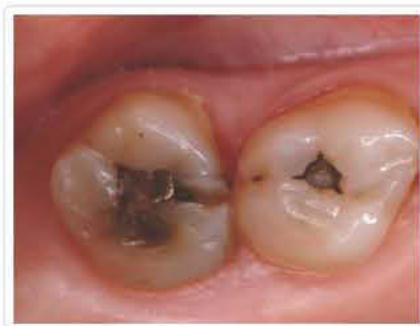
Fig. 19

A 65-year-old patient came in for a routine checkup, with no complaints of sensitivity or other symptoms. Examination revealed that Tooth #15 displayed numerous cracks into the dentin (Fig. 19), which indicated a structurally compromised tooth. The dentin cracks were a result of flexing under function of the tooth weakened by an old occlusal amalgam.

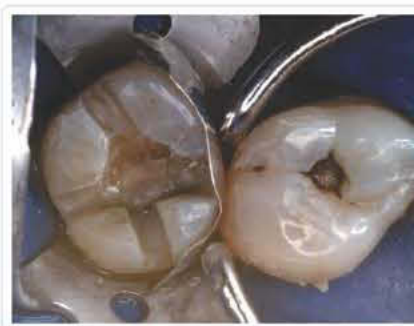
Fig. 20

Again, total isolation was achieved with a rubber dam. After amalgam removal and preparation completion, all internal angles were rounded (Fig. 20) to reduce stress concentration. This improves composite resin adaptation to the dental structure. No bevels were placed on occlusal or gingival margins. Tooth structure bond strength was increased after sandblasting (MicroEtcher) with 35 microns (Crystal Air). Thirty-five percent phosphoric acid (Select HB Etch, Bisco) was applied for 15 seconds, then washed thoroughly. To avoid bond strength degradation,¹⁷ an antibacterial agent such as chlorhexidine 2% (Cavity Cleanser) was applied for 30 seconds, with excess eliminated with sterile sponges. In this case, etch rinse adhesive (OptiBond FL, Kerr) was also used

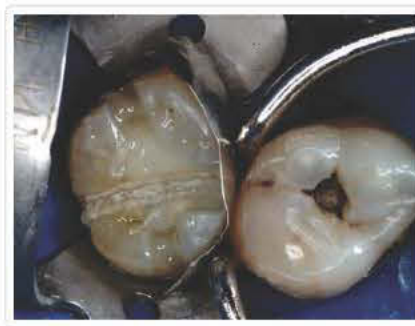
Fig. 21

One piece of fiber is firmly inserted onto the uncured composite in the mesial–distal direction (Fig. 21), while the other is firmly inserted in the buccal–lingual direction (Fig. 22). The fibers are adapted and pressed as close to the pulpal floor as possible, then light-cured.

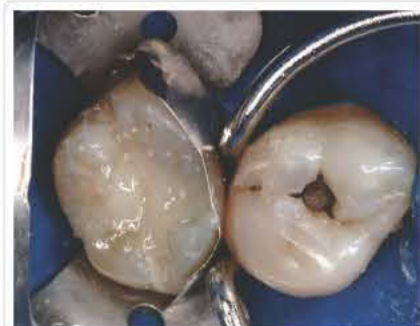
Fig. 23

In one study, SEM found when fibers were inserted into the proximal box depth, little or no microleakage took place, and microtensile bond strength increased the dentin in cavities with high C-factor. Another layer of composite was applied (Fig. 23). The final buildup was done with a prewarmed restorative composite (Tetric EvoCeram, Ivoclar Vivadent) to increase durability.¹⁹ Tints (Color Plus) were placed to create a tertiary anatomy (Fig. 24), then light-cured. After removing the rubber dam, the occlusion was adjusted and remained with light centric contacts. The pointy cusps of opposing teeth were smoothed to reduce tensile forces.²⁰

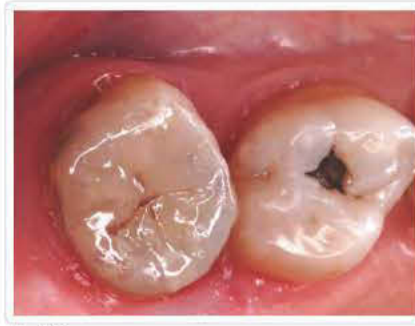
Fig. 25

Next, the restoration was contoured, then polished with an intraoral polishing paste (DiaShine) using a latch brush. A light, continuous contact is kept to provide a higher surface luster. A sealant layer (OptiGuard, Kerr) was applied to seal the small cracks from finishing procedures (Fig. 25). As a preventive measure for occasional bruxism, the patient was provided with a personalized night guard.¹⁵

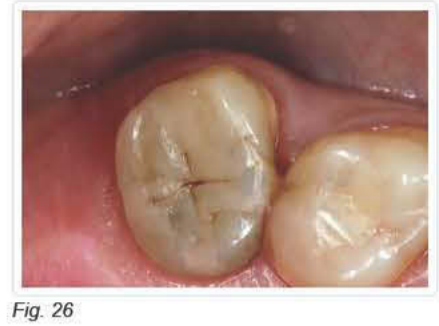
Fig. 26

The restoration has kept up at its 10-year follow-up, demonstrating an absence of any crack extension into the pulpal floor (Fig. 26). As in Case 1, the only thing I'd do differently today would be to use Ribbond Securing Composite, for easier placement and ideal adaptation of Ribbond fibers to the teeth.
